GEARED CONTINUOUS HINGE CYCLE TEST

**SELECT hinge surpasses
25,000,000 cycles at
Architectural Testing, Inc.**

ANSI A250.4-1994 TEST PROCEDURE

REPORT NO. 47291.13-201-44

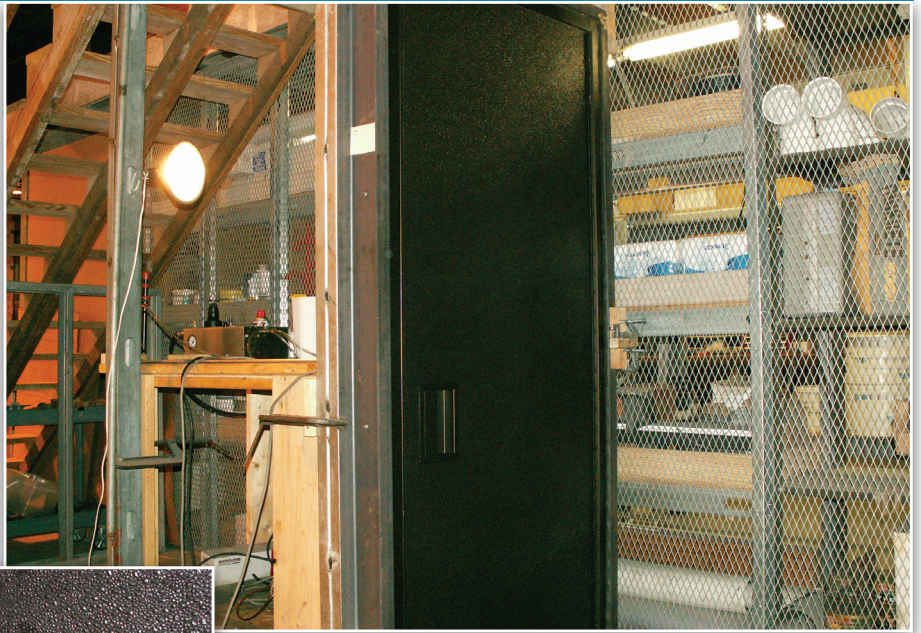
Above: Front view of FRP door and channel iron framework assembled for cycle testing.

Our SL11 HD600 geared continuous hinge surpassed more than 25,000,000 cycles — 25 times beyond Grade 1 BHMA cycle count — in ANSI-approved physical endurance testing. In the real world, that's equivalent to more than 60 years on a typical high-traffic entrance.

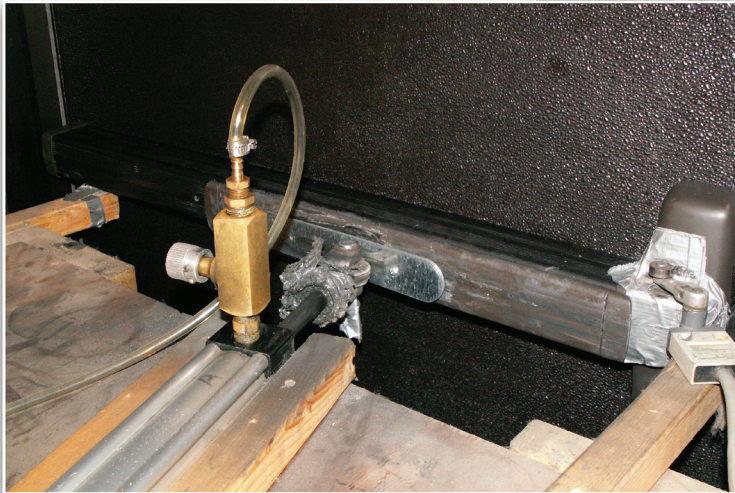
Left: Open/close actuator attached to panic bar exit device.

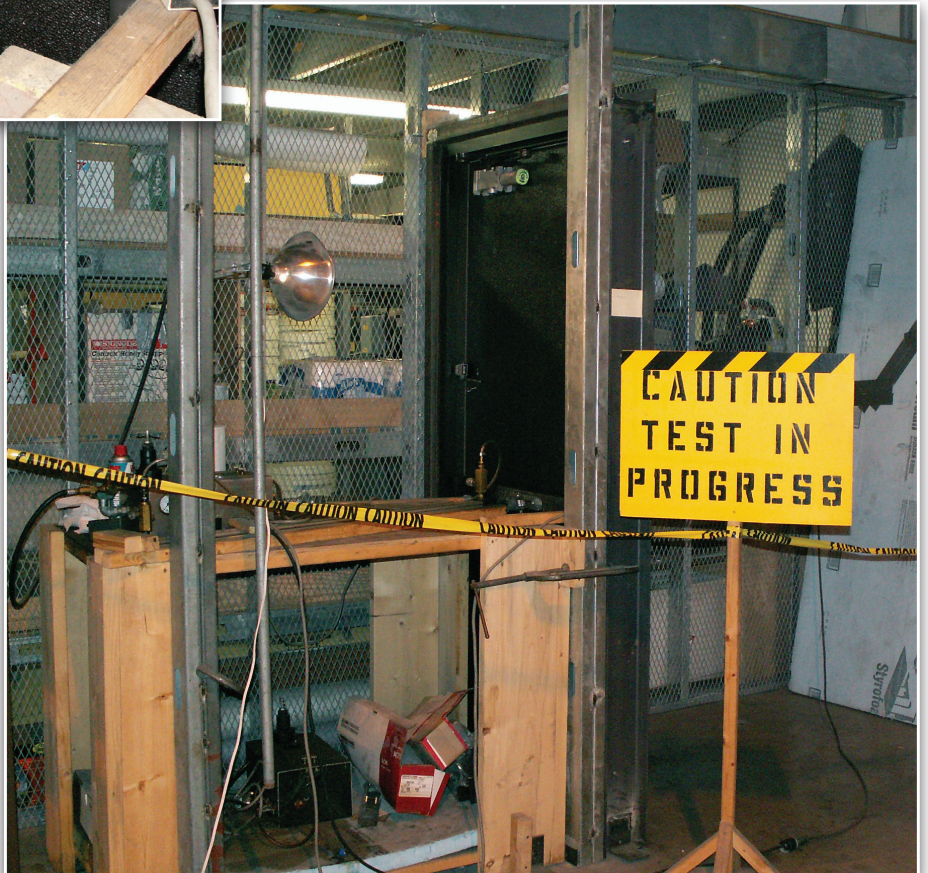
Below: Cycle test setup at Architectural Testing, Inc., St. Paul, MN. Note the empty packaging from two door closers. The first of two failed door closers was replaced after only 4,803,830 cycles.

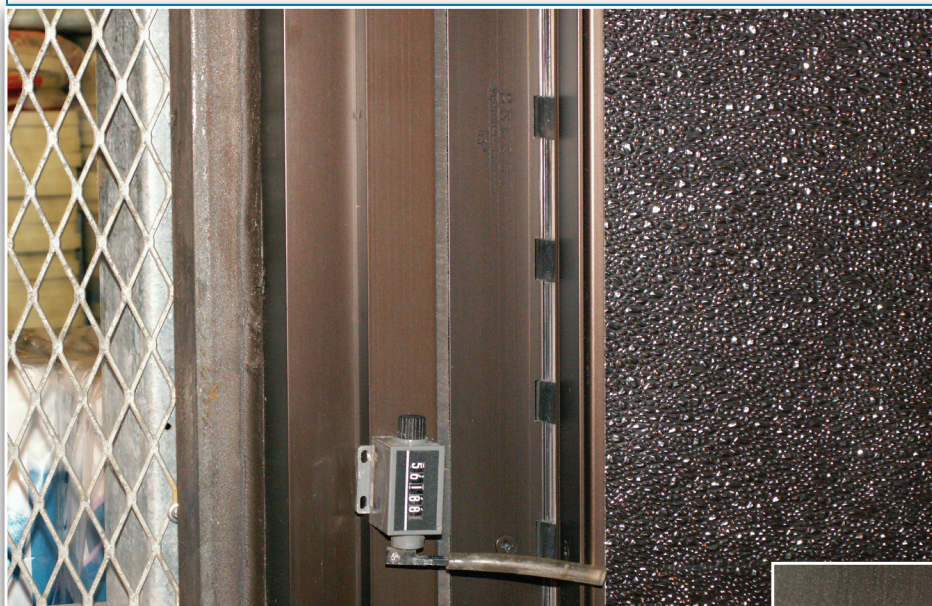
Above: The last of three cycle counters installed on an FRP door equipped with SELECT's SL11 geared continuous hinge. Two counters were replaced before reaching 25,000,000 cycles.

How do you know SELECT Hinges™ will hold up to years of heavy traffic moving through your doors? Because independent tests prove it. What kind of damage did all those test cycles cause? A broken counter. Two worn out door closers. And no measurable change to the hinge or door.

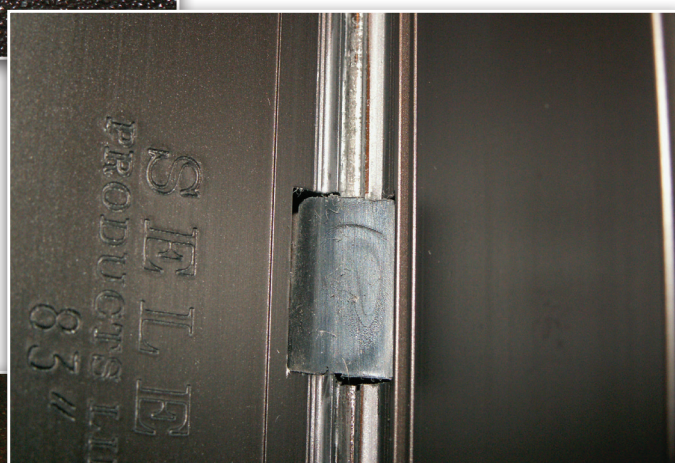
Right: Load bearing after 25,000,000 cycles.

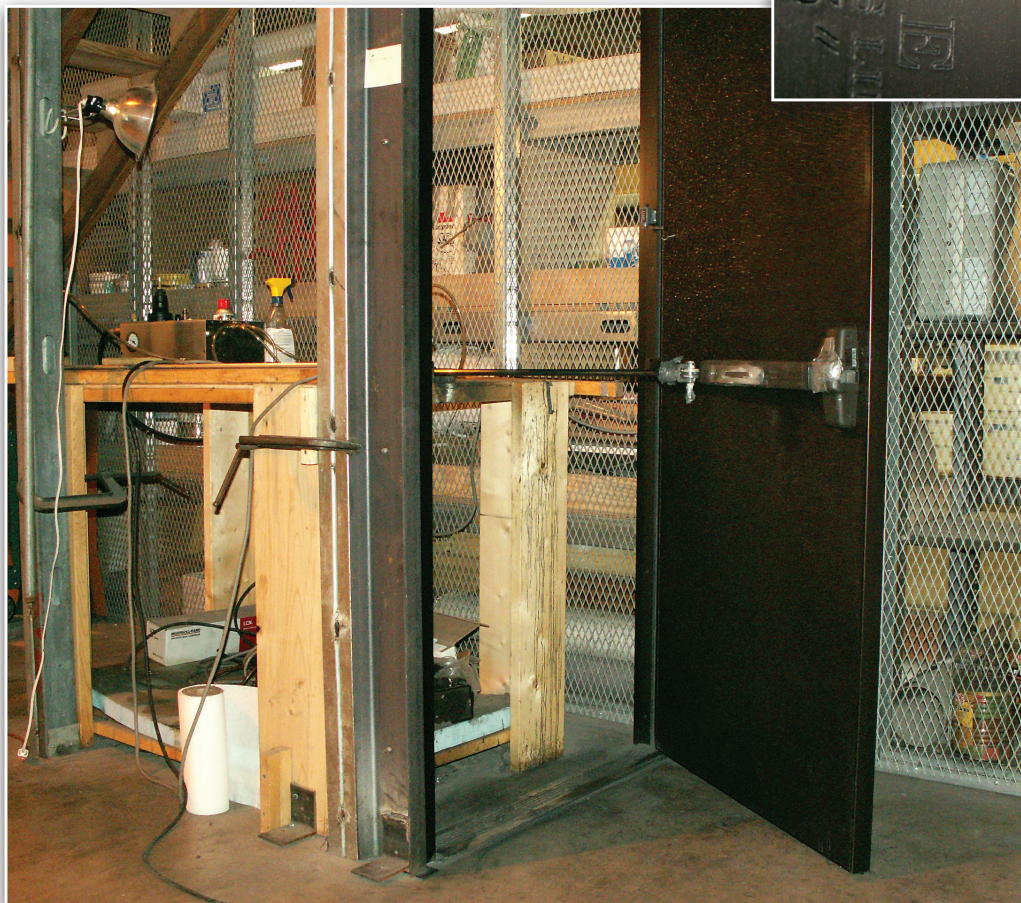
Below: Front view of cycle test setup in operation at Architectural Testing, Inc., St. Paul, MN.
